These days it would be called an "inflight upset," though some might refer to it as "unauthorised aerobatics" but within Qantas it was and still is called simply "the Bahrain Bomber"

The place had been a-buzz with rumours for a few days about an incident involving a Qantas 707, VH-EAB, between Bangkok and Bahrain.

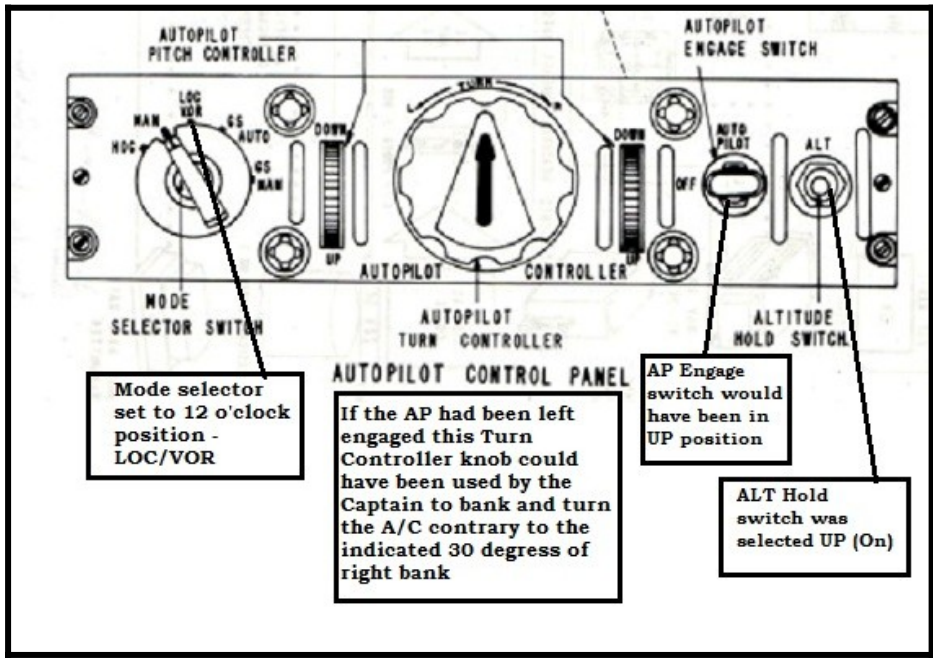
A fairly generic AutoPilot panel from the 60's. This one was situated on the pedestal, between the two pilots

The Autopilot was flying the aeroplane, following the pre-selected “radials” to and from Jiwani, and holding the aircraft steady at 35000 feet.

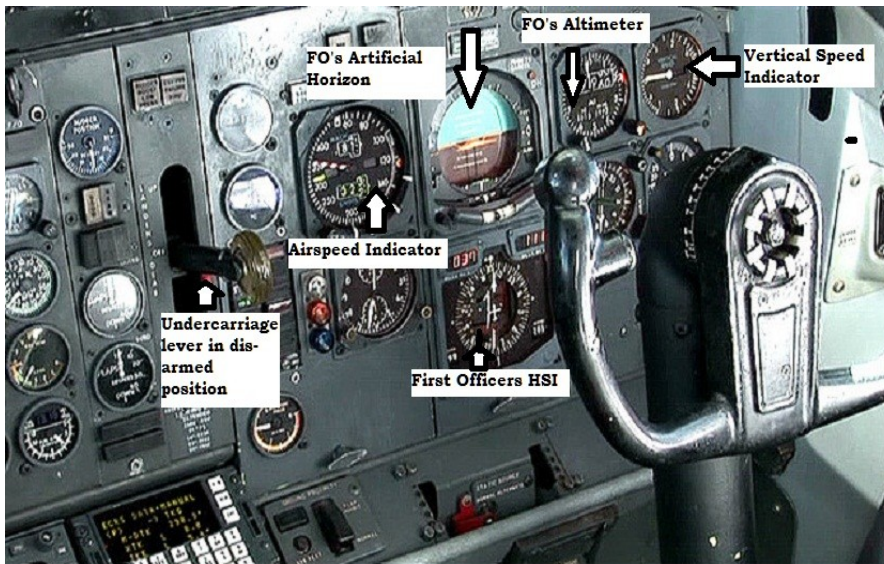
The FO's instrument panel (currently in front of the Second Officer) should have looked like this, but without the labels obviously.

Instead, the Airspeed Indicator needle was well into the “red” and past the barber’s pole maximum value. The bar separating the turquoise (sky) and black (ground) of the Artificial Horizon was nearly vertical and showing mostly black anyway.

Normally, faults or power failures in the primary flight instruments are accompanied by a warning "flag" which partially obscures the offending dial.

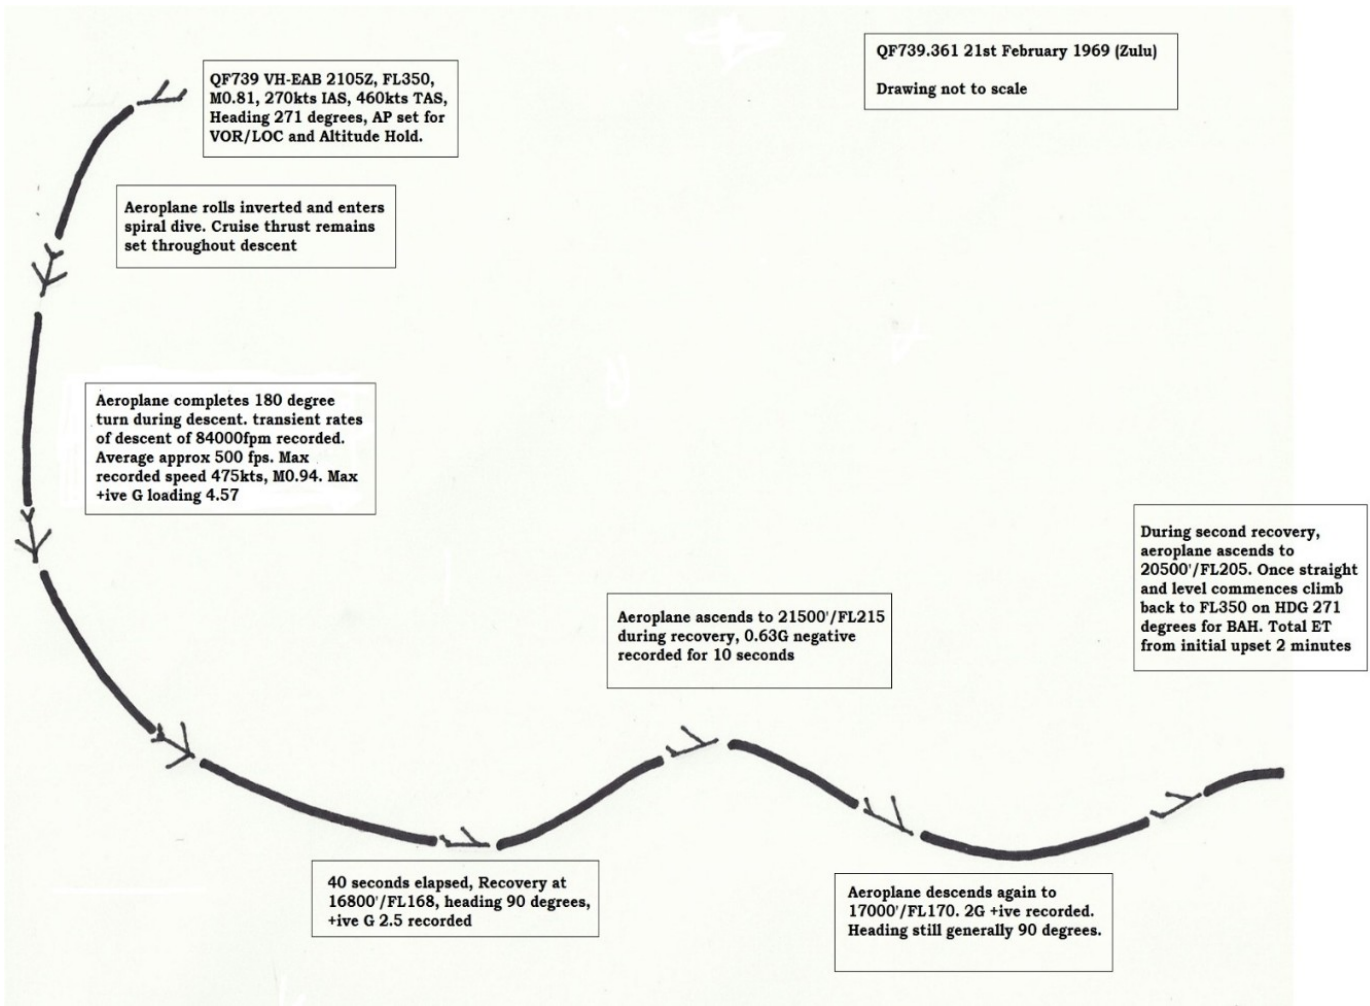
Your "speedo" will peak at about 610mph (980kph).

So theoretically, VH-EAB's speed should have stabilised around this value, but remember she brought a lot of speed into the "upset" and her 4 JT3s were all still producing cruise thrust.

Gravity alone will cause an object falling through the atmosphere to accelerate to a limit referred to as Terminal Velocity, where the resistance of the atmosphere itself will exactly match gravity’s attraction, and the object will continue its plunge without further acceleration.

At the speeds reached by EAB, compressibility issues around the entry to the pitot tube would have caused the gauge to read conservatively, and her speed was probably greater than that displayed on the gauge or recorded on the FDR trace.

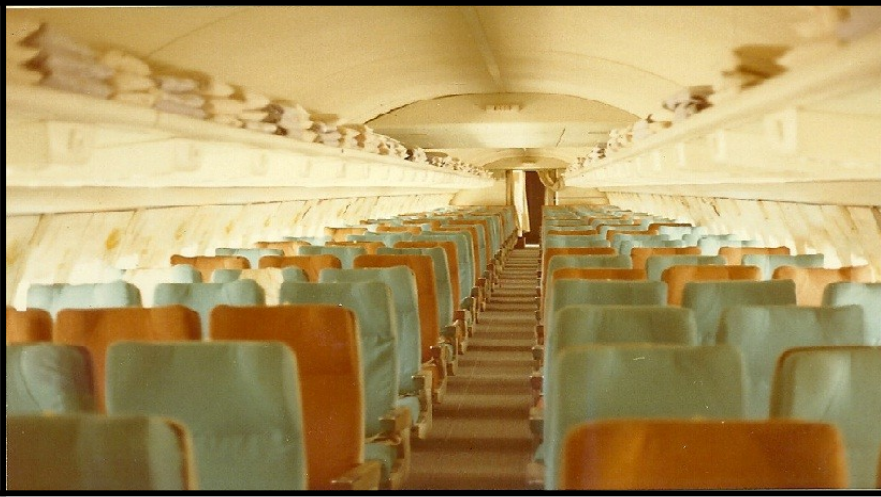
The Cabin on an all Economy B707. The overhead racks pretty much from where the photo was taken, aft, were badly buckled and bowed.

If they'd been allowed on board, they would probably have noticed immediately the pervasive smell of stale alcohol, vomit, sewerage, fright and Racasan in the cabin, and couldn't have missed the bowed and bent overhead luggage racks.
